**LA VILLITA RFP – EXHIBIT 9**  
**CATEGORY A - WORKING ARTIST STUDIO GALLERIES**  
**BUILDING INFORMATION**

## BUILDING 1

### **Bowen/Kirchner House, c. 1870**

**GENERAL ASSESSMENT RATING: 4-Good**

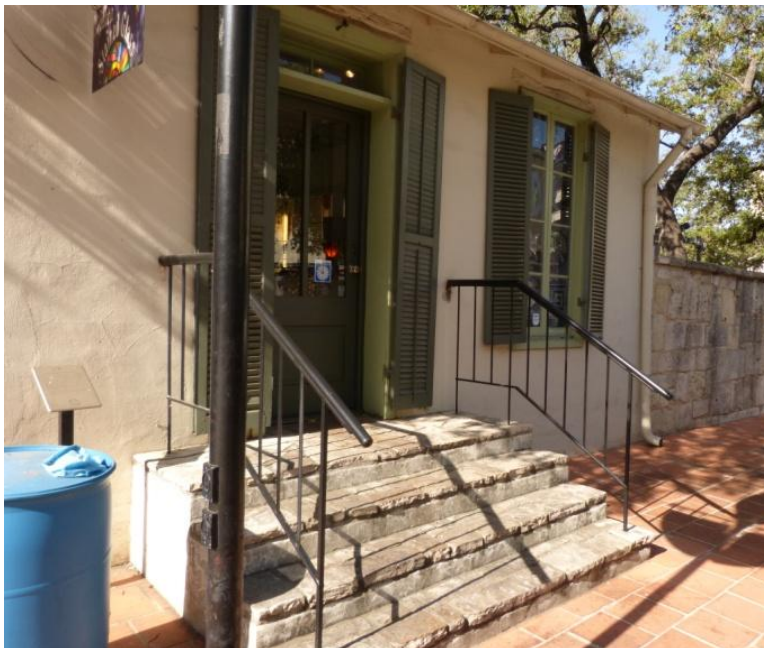
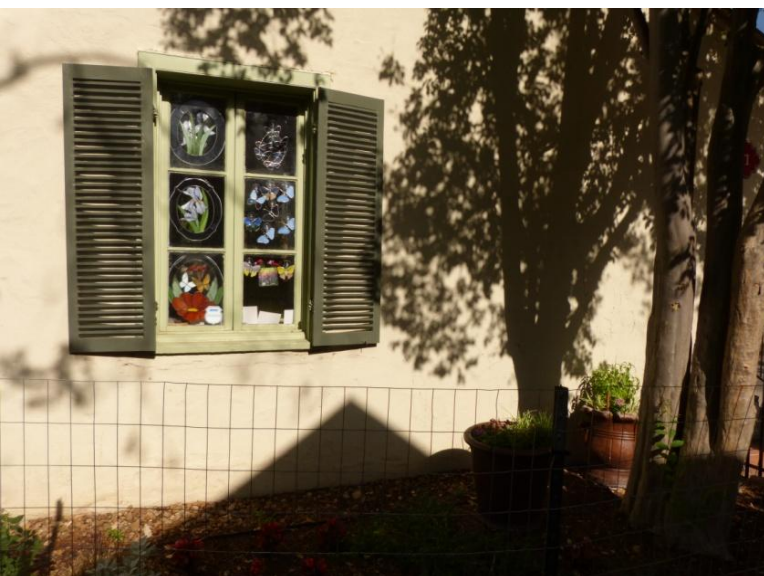
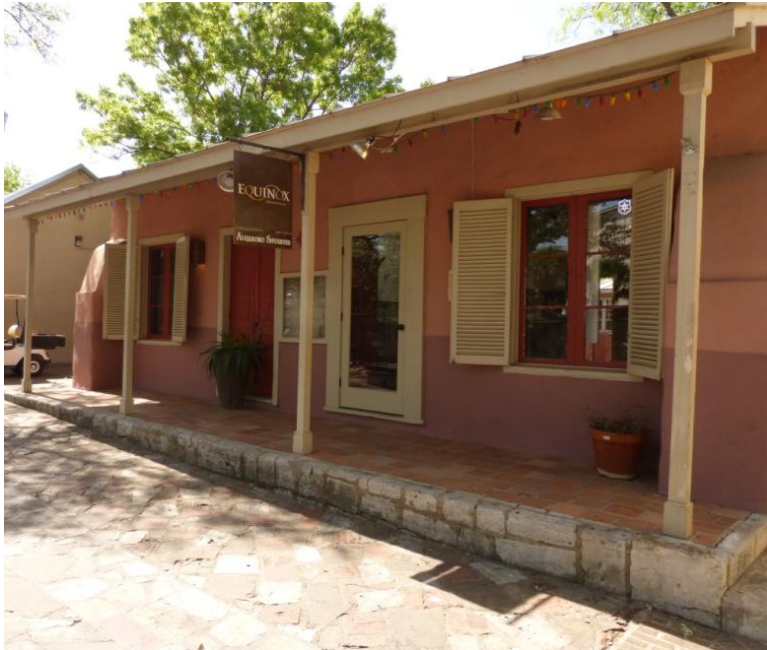
**Walls.** Masonry walls in satisfactory condition. Plaster finish in fair condition but loose in some areas; requires some repairs.

**Roof.** Metal roof in fair condition but needs cleaning at slightly sloping area. Entire roof should be repainted to prolong its function. Gutters need to be cleaned.

**Windows and doors.** Windows in fair condition but need caulking and repainting.

**Air-conditioning and heating.** Chilled water/electric heat fan-coil installed in 1980s reported by tenant to be sufficient. Unit does not bring in outside air.

**Electrical.** The interior panel board appears to be in working order but does not have an interior cover nor any additional capacity. Countertop receptacle near the sink is not GFCI type.

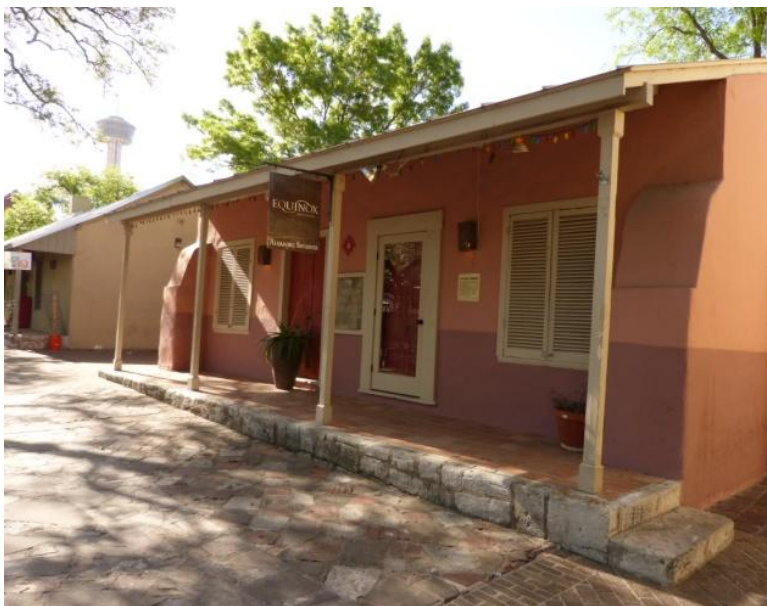
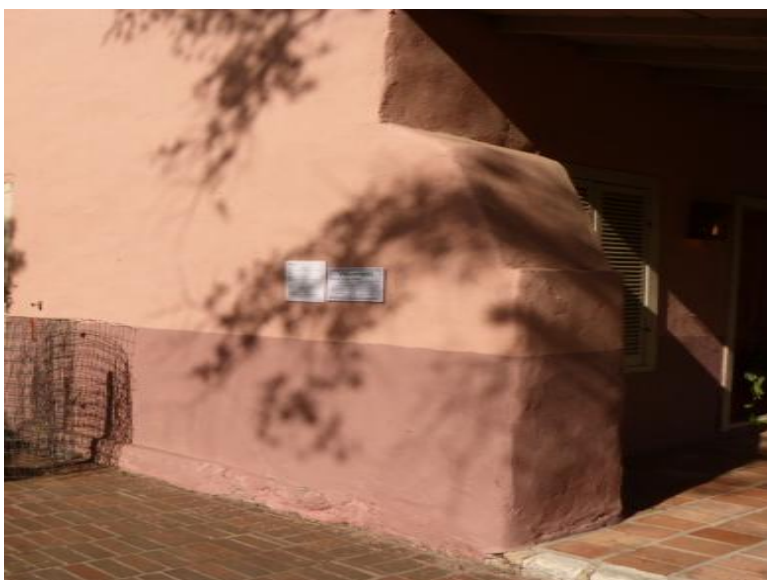
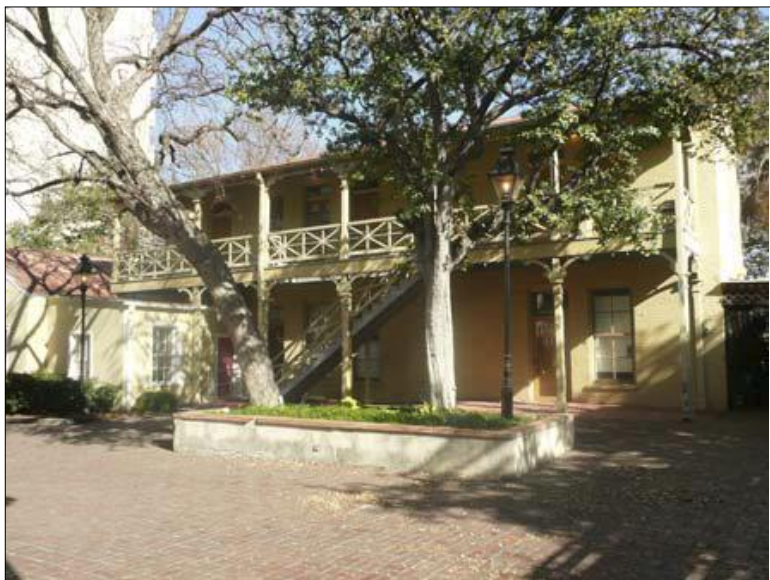
**Walls.** Masonry walls in structurally sound condition. Plaster finish is generally well-adhered to masonry.

**Porch.** Porch floor on south side needs wood decking repairs and repainting.

**Ceilings.** Old Sheetrock over painted boards has recently been painted. An area of ceiling removed to access the attic needs patching.

- **Air-conditioning and heating.** Tenant considers existing 1980s chilled water cooling/electric heating fan-coil to be an “antique” and marginal in ability to maintain temperature during the summer. No outside air is brought in by the system. Condensation drips through the connecting pipe insulation.
- **Plumbing.** None except condensation piping.
- **Electrical.** Interior panel board appears to be in working order but is an older model. It may become increasingly difficult to acquire new circuit breaker replacements. Surface raceway along interior stucco walls appears to be rusting at potential attachment points. Tenant pointed out drips along wall that appear to emanate from the raceway.

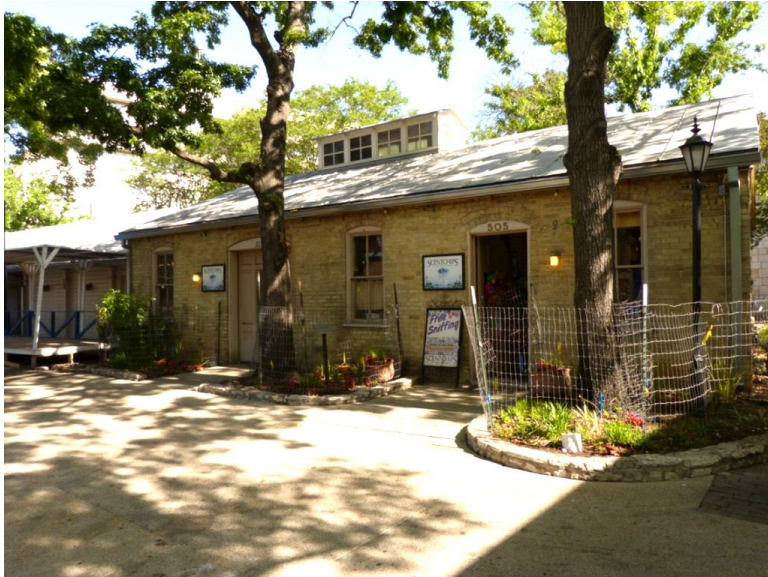
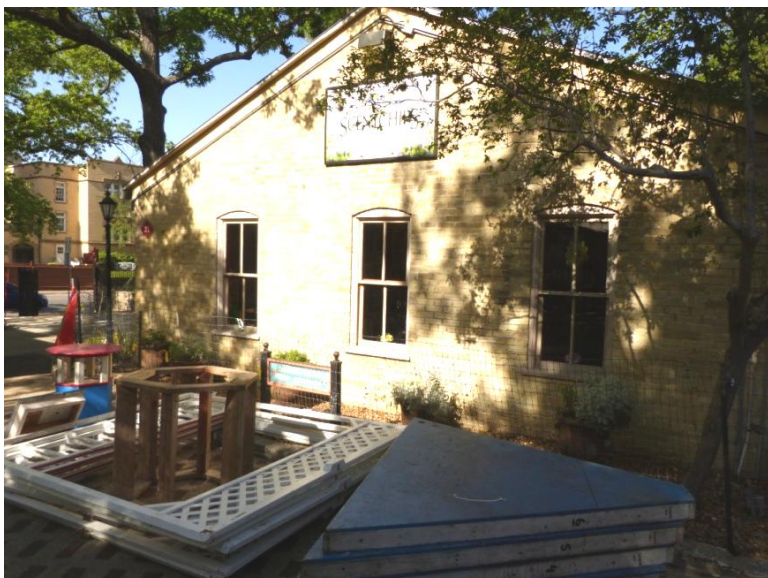
**Walls.** Exterior brick in fair condition.

**Roof.** Standing seam metal in serviceable condition; clean, inspect and paint if rust is beginning to form.

**Windows and doors.** Most windows require major repairs or replacement. North door and large sliding door at south wall should be replaced.

Northeast corner of building has cracked and buckled, probably from ground movement caused by water. Wall needs to be rebuilt from approximately 4 feet above the floor to the roof.

Replace paving at main entrance door to create single gently sloping area to meet TAS.

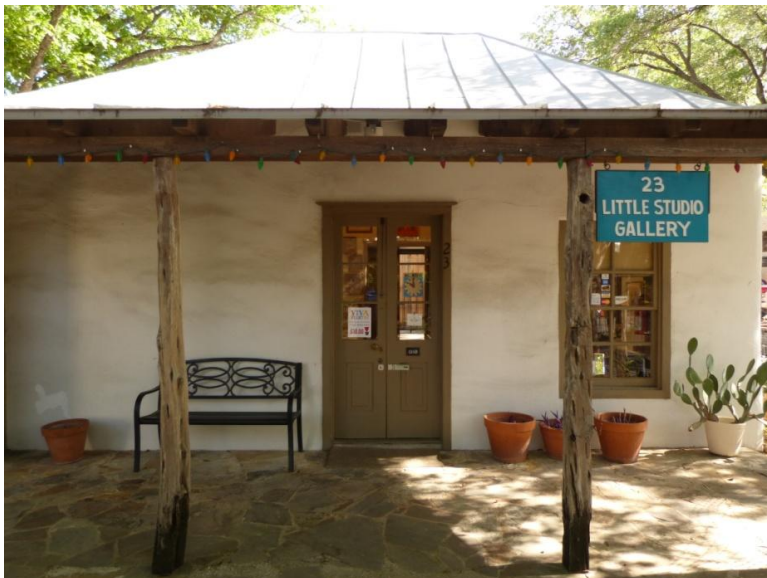
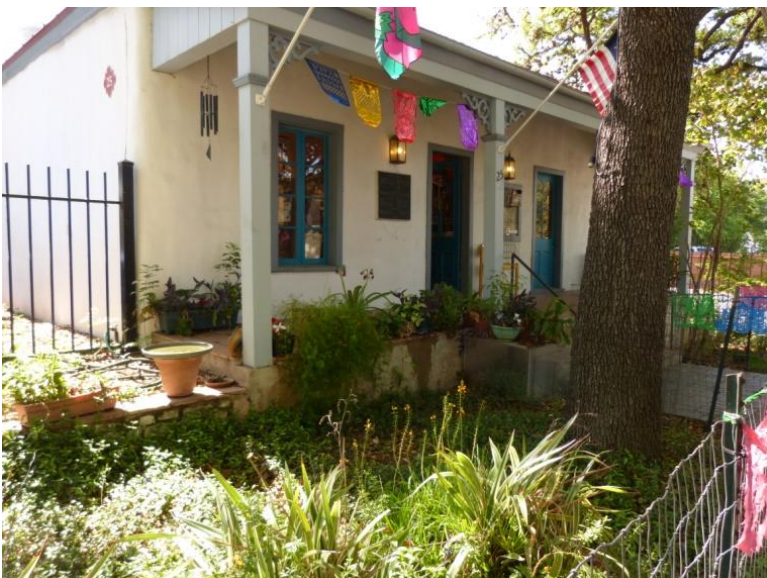
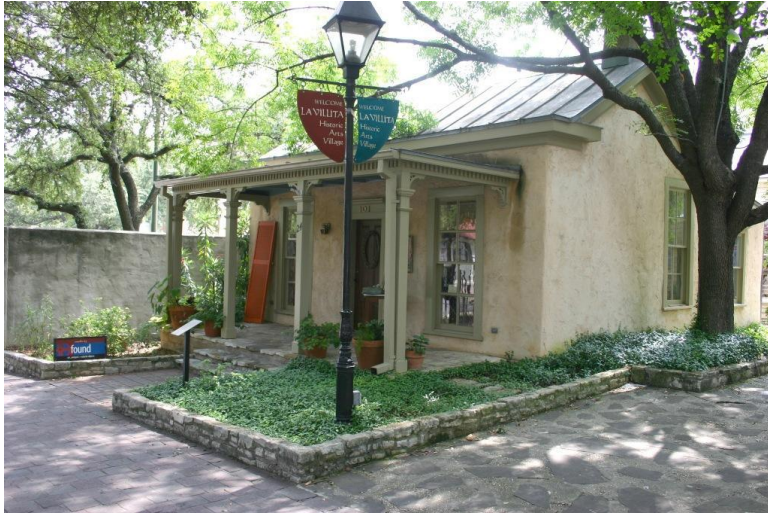
**Walls.** Walls are in good condition with a few cracks. They were completely repointed in 1982. Miscellaneous repointing is required.

**Roof.** Metal roof appears to be in good condition although some rust is visible and it may need repainting.

**Walls.** A combination of exposed beaded board and plaster, walls are almost completely covered by tenant's pegboards. In satisfactory condition. City will require removal of pegboard.

**Air-conditioning and heating.** Suspended chilled water cooling/electric heating fan-coil unit said by tenant to be adequately sized. Condensation leaks occur occasionally.

**Electrical.** Electrical appears to be in good working order. Exterior receptacle is not weatherproof or GFCI type.

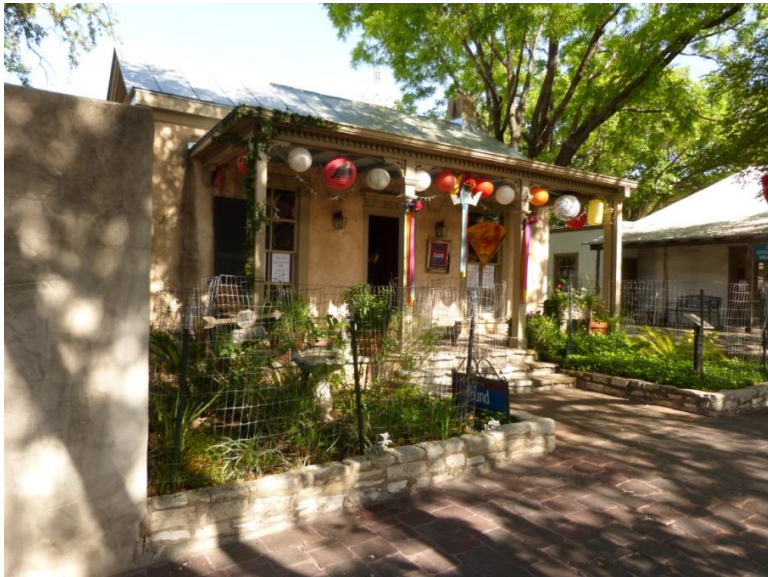
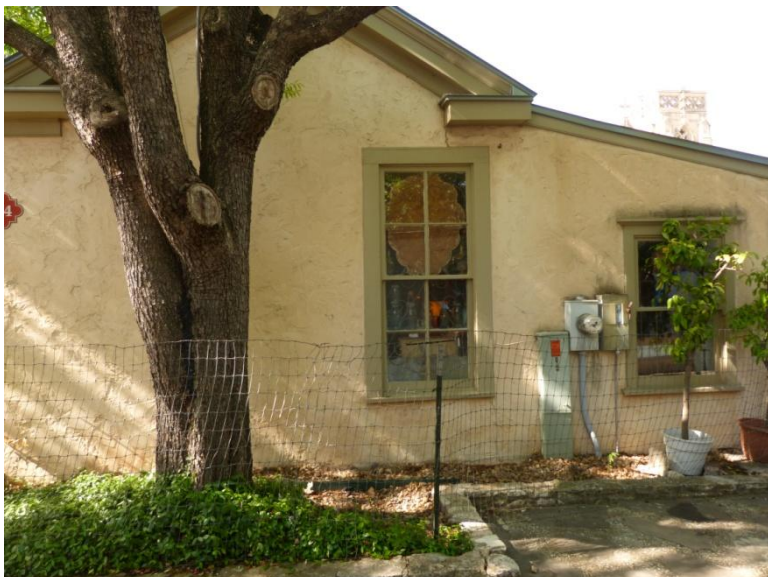
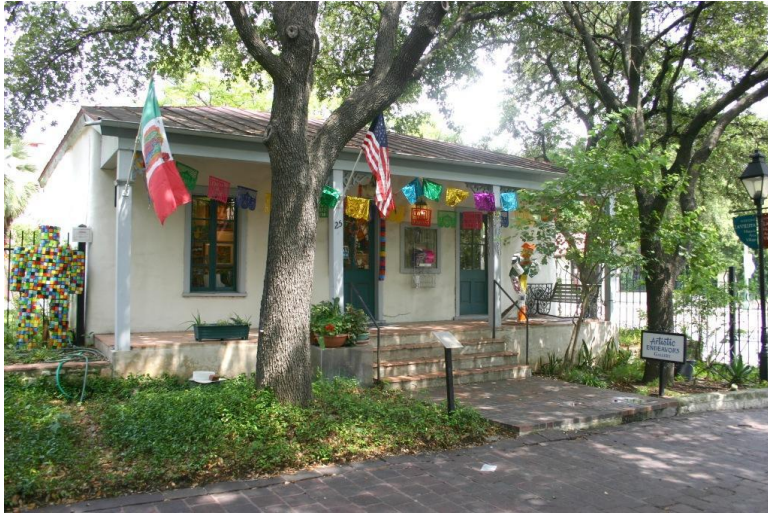
**Walls.** Masonry with cement based stucco. Stucco should be tested for cement content, and if it is found to contain cement rather than lime, the stucco should be removed and replaced with lime-based plaster. Crack in north wall through larger window.

**Roof.** Metal roof appears to be in good condition. Rear gutter is not properly attached and therefore is not catching rainwater. Downspout is mashed so that it does not allow water to flow freely away from structure.

**Windows and doors.** Some windows and doors have been removed, and the others repaired. Plywood placed over window and door openings to make building weather-tight.

**Walls.** Walls are a combination of exposed stone, gypsum wallboard and plaster. Fair condition. Signs of rising damp in walls.

Building not accessible because of raised floor level at retail level. Risers greater than code allows. Install handrails at front entrance.

- **Air-conditioning and heating.** Chilled water cooling/electric heating unit said to be undersized and reportedly has had frequent problems with condensation overflow.
- **Plumbing.** Existing cold-water-only two-compartment sink with Formica countertop appears to be tenant-provided. Water was backed up into both sink bowls on the day of our walkthrough.
- **Electrical.** Electrical appears to be in good working order. Receptacle near sink is not GFCI type.

Eliminate planting beds at north side of building, including removal of large tree, which could damage foundation. Assure proper drainage away from building on all sides.

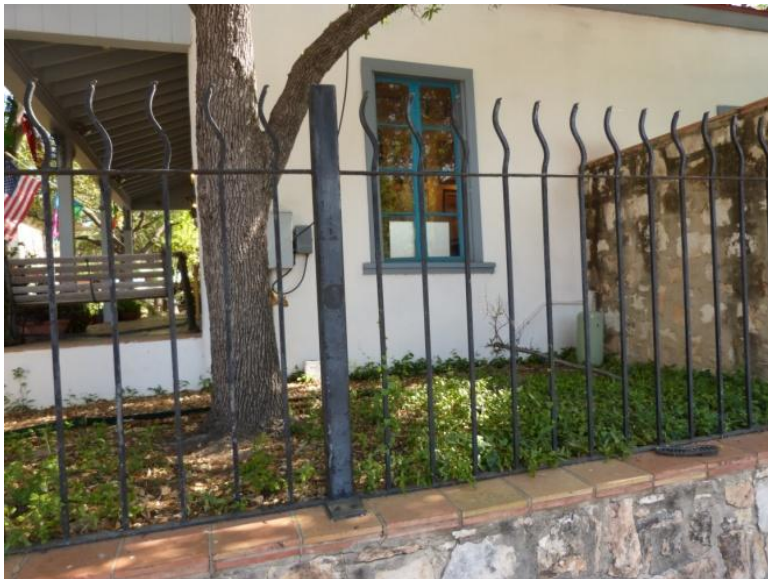
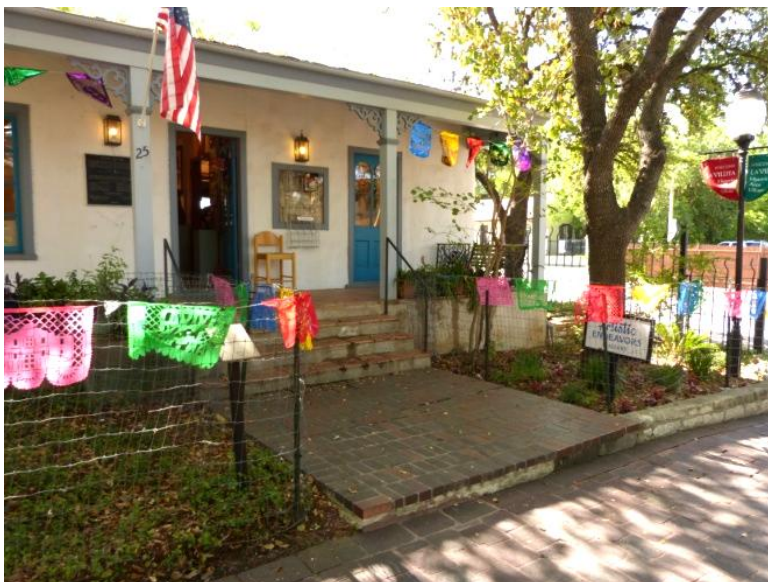
**Walls.** Walls are in good condition with a few cracks. Miscellaneous re-pointing required.

**Windows and doors.** Wooden window frames and doors need some repair. Currently under repair.

**Floors.** Wooden floors in satisfactory condition but could be upgraded with new wooden flooring. Some deterioration at rear, possibly from rot or termites.

**Air-conditioning and heating.** Chilled water cooling/electric heating 1980s fan-coil reported by tenant to be sufficient on average days, but insufficient on extremely hot days. Fan sounds noisy.

- **Electrical.** Electrical system originates from Building 9 so tenant does not control circuits. Tenant concerned that only two branch circuits appear to feed lighting and receptacle loads for this building. Tenant reports that local photocell for streetlights timer for exterior lighting do not work. The means for disconnecting HVAC unit is on the outside of the building and does not seem readily accessible.
